Case studies: Baliyanala and Kedarnath

H. C. Singh

Executive Engineer,

Irrigation Division Nainital

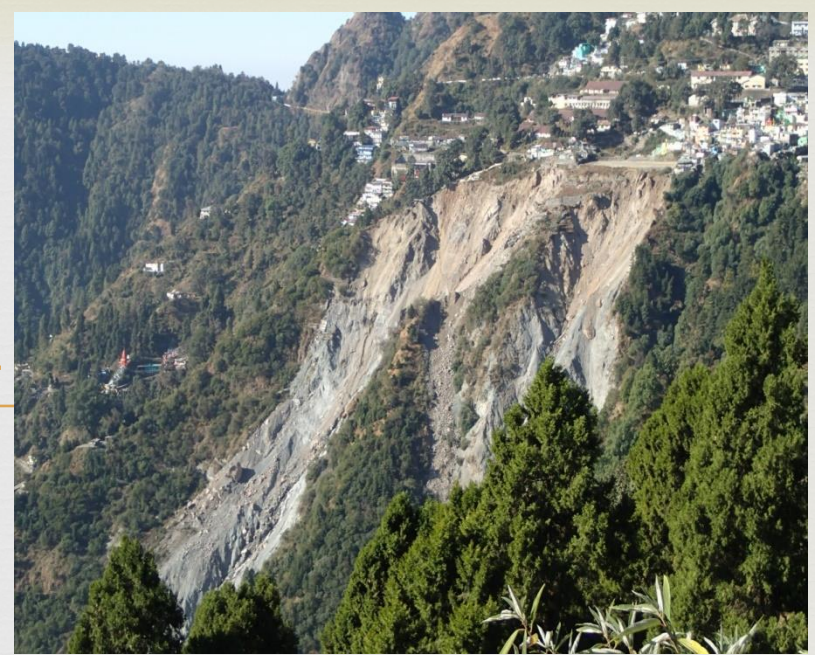
View of target slope

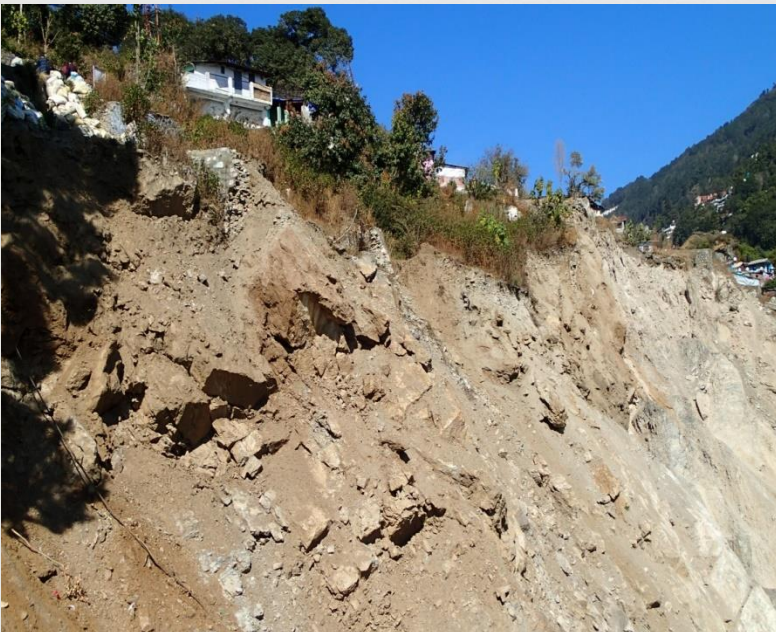
Failed slopes

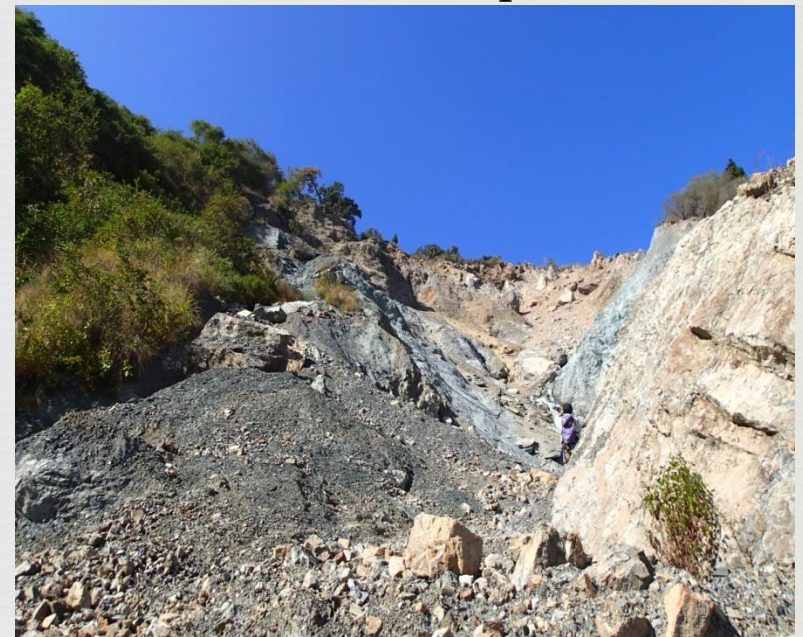
Scarp of failed slope - Loosely held

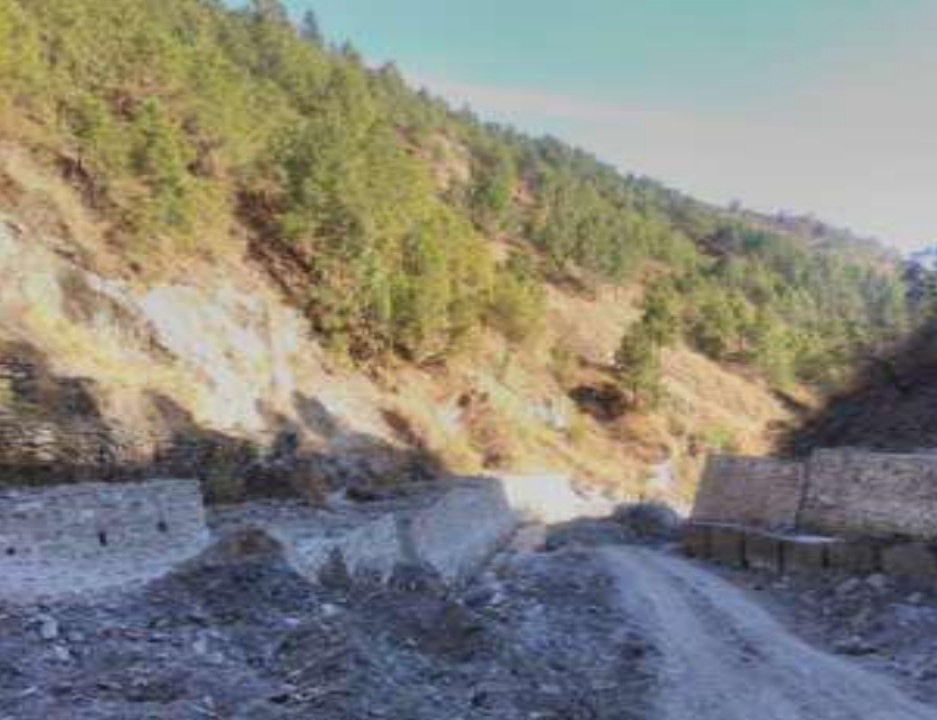
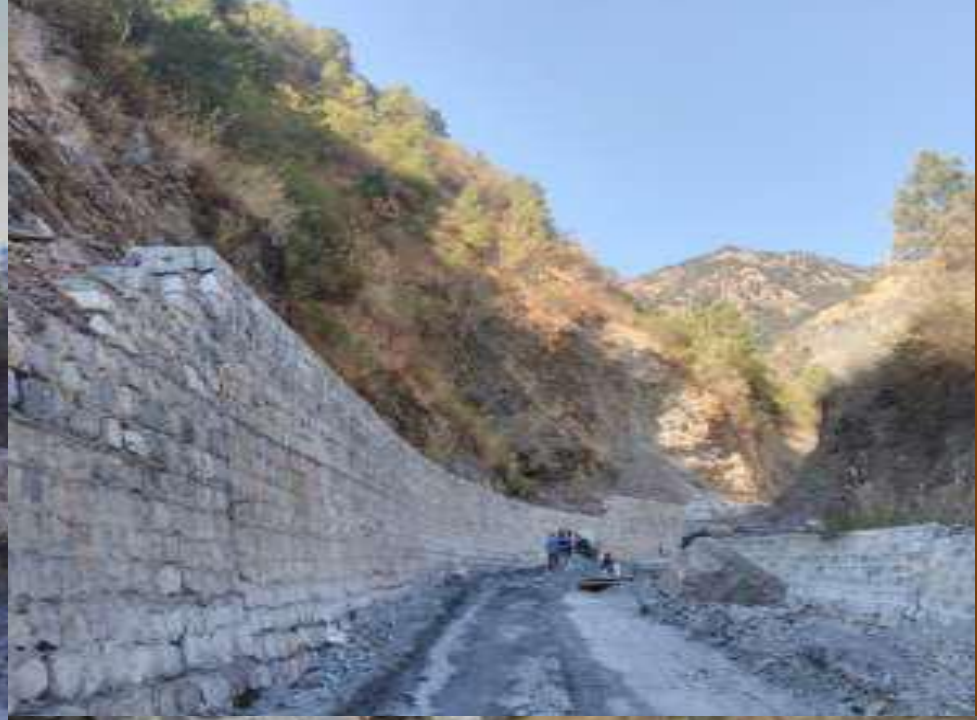
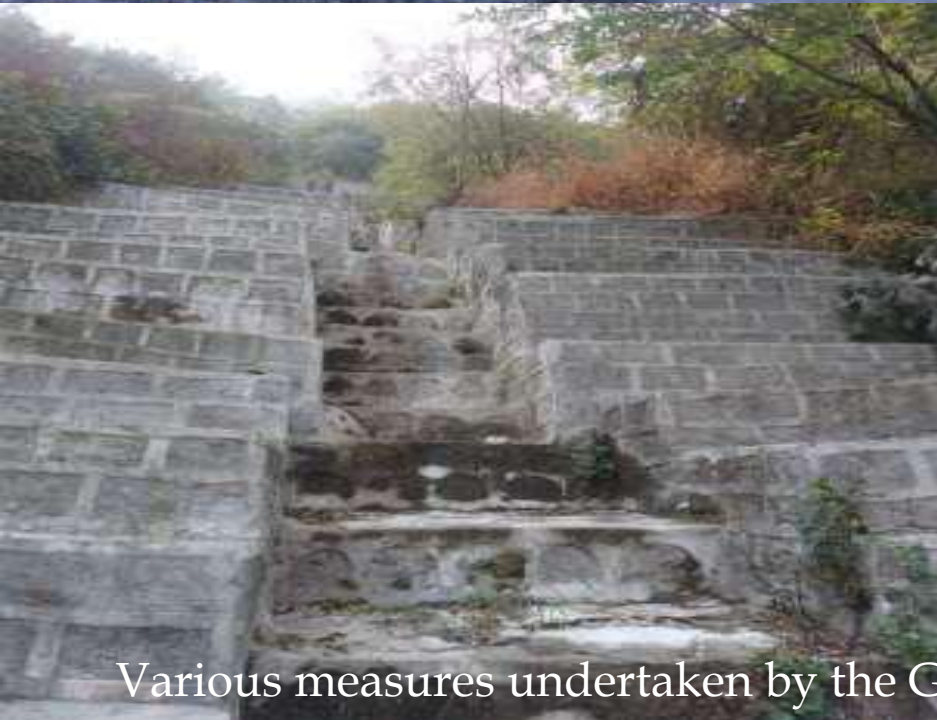
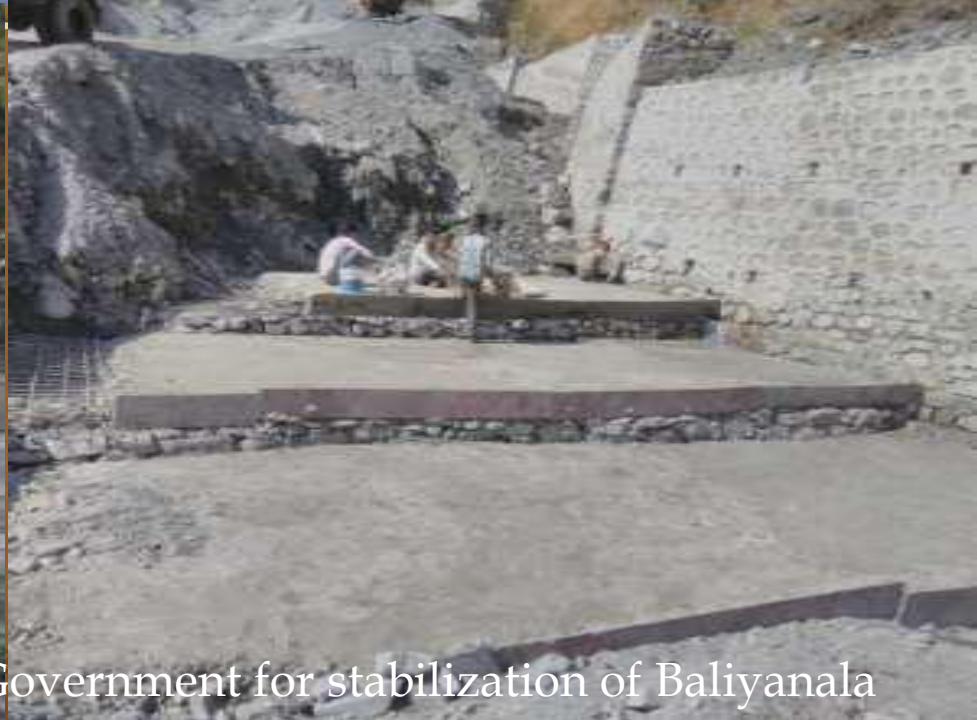
Loose debris covers the bed rock

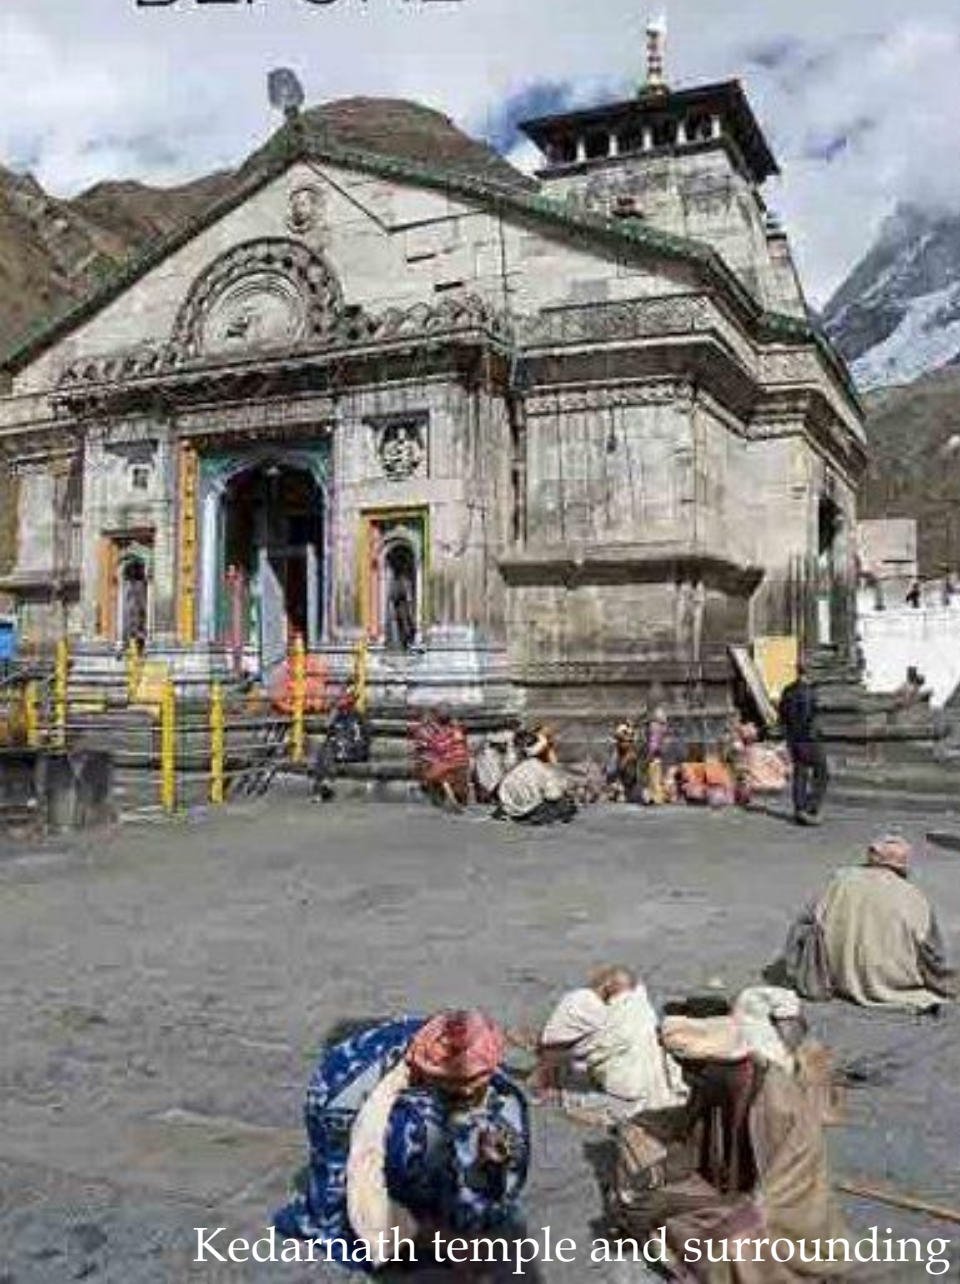
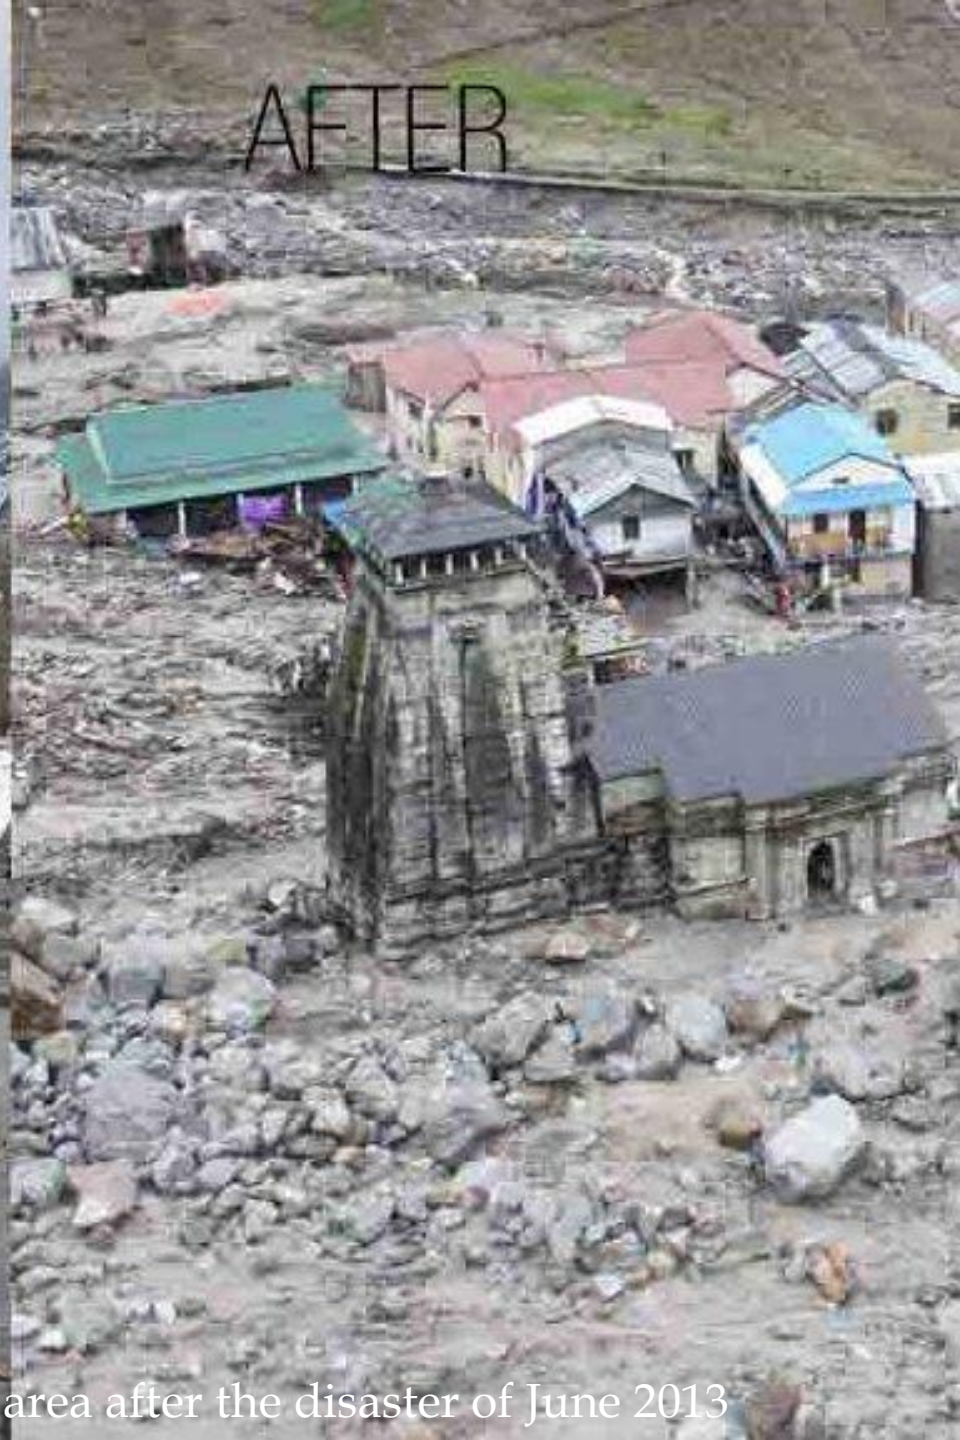
Kedarnath temple and surrounding area after the disaster of June 2013

There was a catastrophe in Mandakini valley on 16th & 17th June 2013 due to bursting of Chorbari Lake which was situated at an elevation of approximately 3746 m above mean sea level upstream of Sri Kedarnath temple, one of the holiest Char Dham of Uttarakhand, the total area of the Chorbari Lake is 25450 Sq.m. This catastrophe occurred during the very heavy rainfall between 14th June to 18th June 2013 in the catchment area of Mandakini River in District Rudraprayag (The rain fall recorded at Tharali & Jakholi Tehsil Headquarters of the Rudraprayag district was 326 mm & 390 mm respectively. Due to this intense rainfall, the runoff exceeded the storage capacity of Chorbari Lake due to narrow outlet of the Lake, also this very heavy downpour washed away the debris on the hillslopes deposited by the moving glaciers. The runoff due to very heavy rainfall along with the water released due to the bursting of the Chorbari Lake created havoc in the Mandakini Valley, wherein there was a very loss of human life, the pilgrims on way and returning from the divine Shri Kedarnath Dham and also to the properties in the valley. There was an abnormal flow in the Mandakini River due to unprecedented rainfall as well as the very heavy flow of debris washed from the steep mountain slopes. Also, there were innumerable landslides all along the valley at various locations, resulting in the disruption of traffic. The unprecedented flow in the Mandakini river caused heavy erosion along the banks of the river. A lot of debris were deposited in the river bed, at some places, the depth of deposition was even upto 5-8 meters, which further aggravated the situation, wherein even the habitations on the high bank were also eroded. All along the river course of Mandakini River, habitations e.g. Rambara, Gaurikund, Sonprayag, Sitapur, Guptkashi, Kund, Bedubagar, Tilwara etc, were either completely washed away or suffered moderate to severe damages. The right bank of Mandakini River between its confluence to Songanga upto downstream of Sitapur town was severally damaged due to narrow gorge of the river downstream of Sitapur town. The parking ground and house situated approximately 10-15 meter above the river bed was eroded due to rise in the water level of the river in this river stretch.

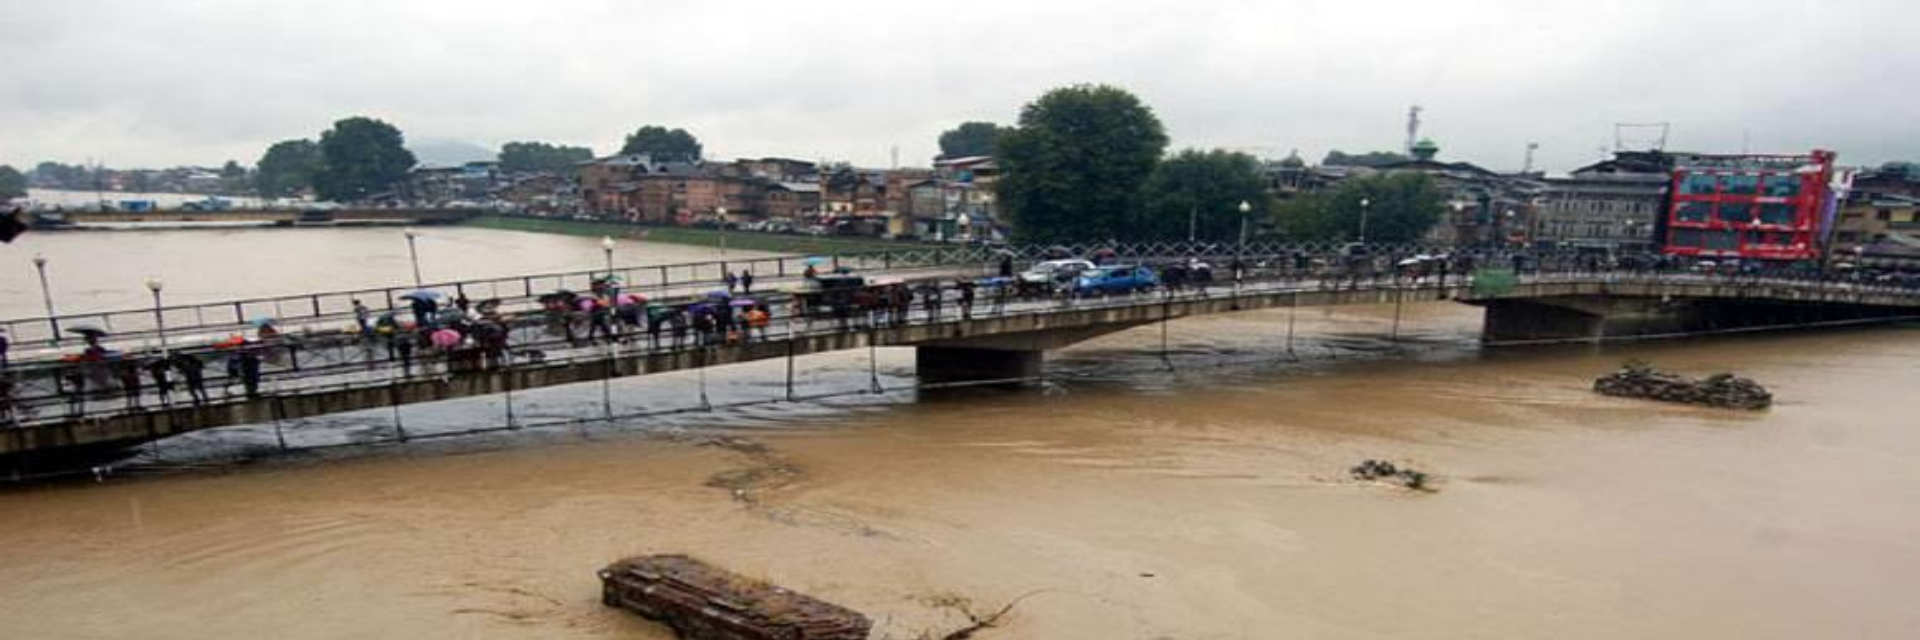
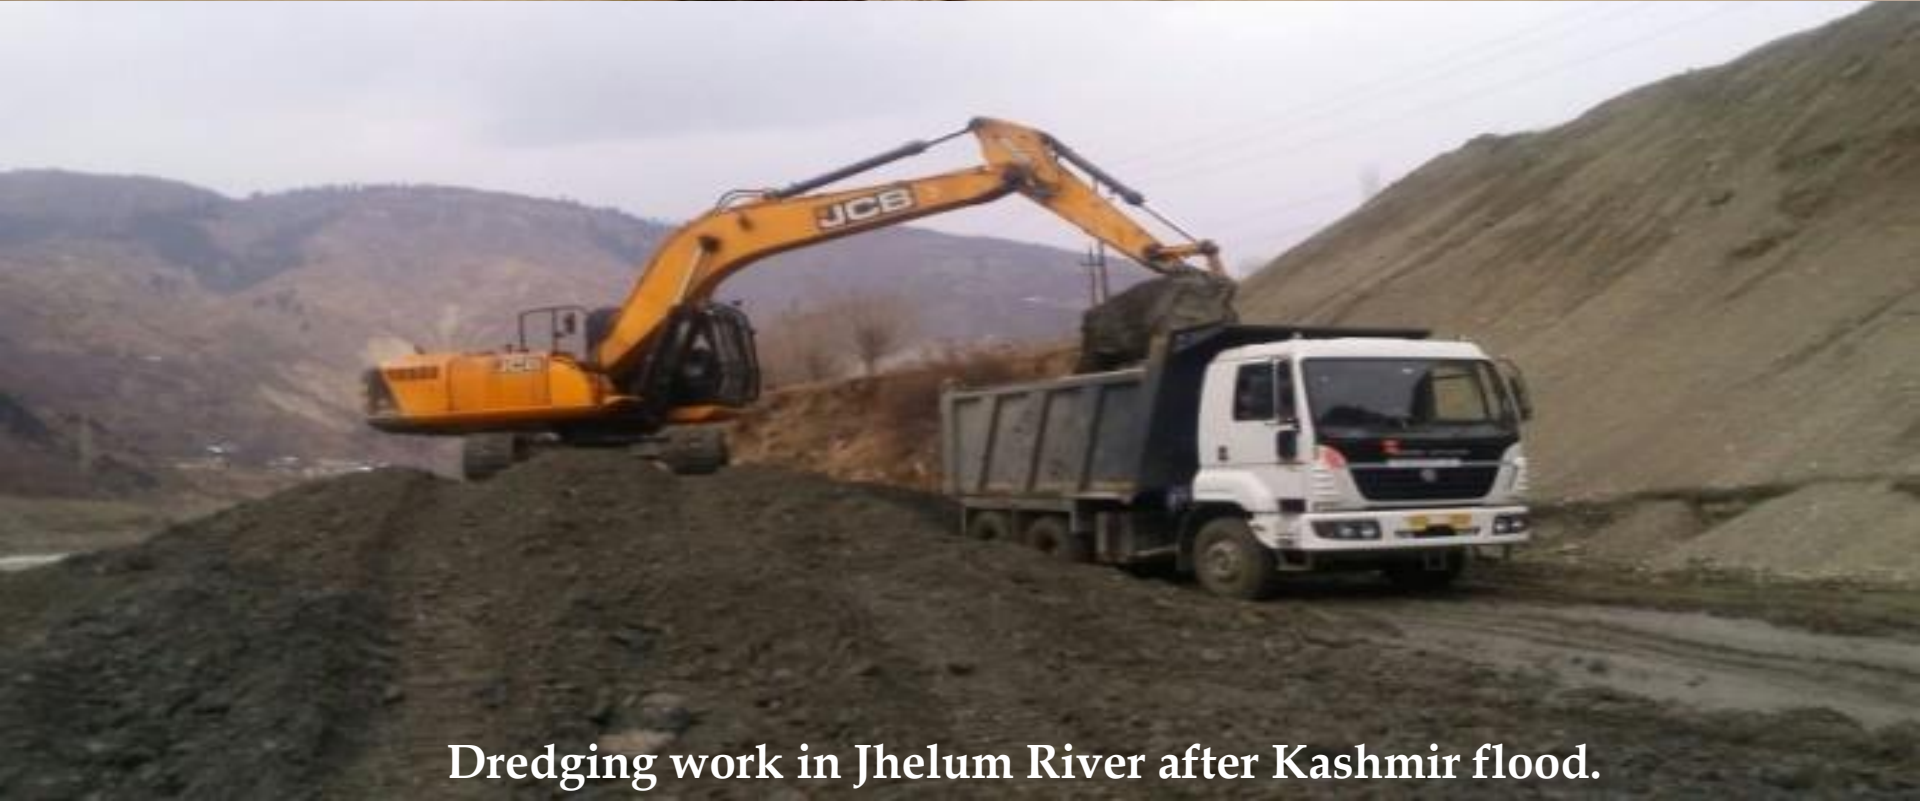
Dredging work in Jhelum River after Kashmir flood.

Channelization work of Jhelum river, the river section is being widened and slope is proposal to be steeped from very mild to enhance the discharge carrying capacity of the river, as to avoid the submergence of city population. This can be achieved as the river slope beyond the outfall channel is steeper than that of the Jhelum river in Srinagar city, while as in case of Mandankini river, it is not so & these is every possibility for scouring of bank, movement of debris & dredged bed may be silted in the very first rains/flood so intensive anti-erosion/bank protection works has been executed in Mandakini valley as an protection measure.
