# **Silkyara Tunnel Section Collapse: A Case Study**

**Disaster Management Cell**  
**Dr. R. S. Tolia Uttarakhand Academy of Administration**  
**Nainital**

# **SILKYARA TUNNEL SECTION COLLAPSE: A CASE STUDY**

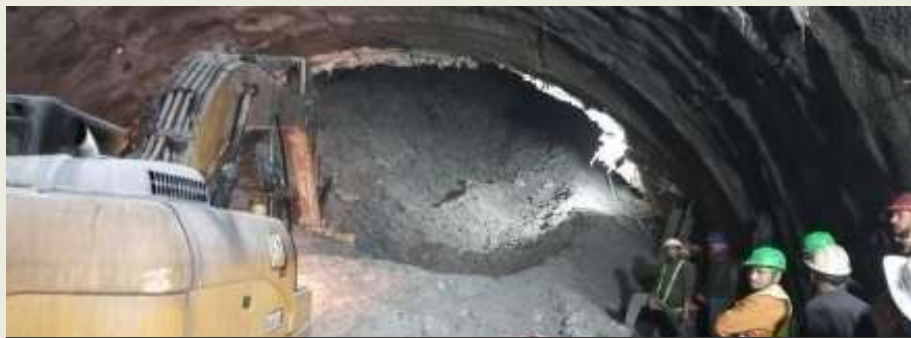
Section experienced the collapse and debris accumulated on the passage

After survey of the area and taking into consideration the discussion with project team on construction site and local administration that combination of geological and structural factors can be the potential causes where a tunnel section collapsed:

In the case of the collapsed tunnel section, the combination of a hidden loose patch of rock and on-going water seepage might have created conditions that were difficult to identify during the construction phase.

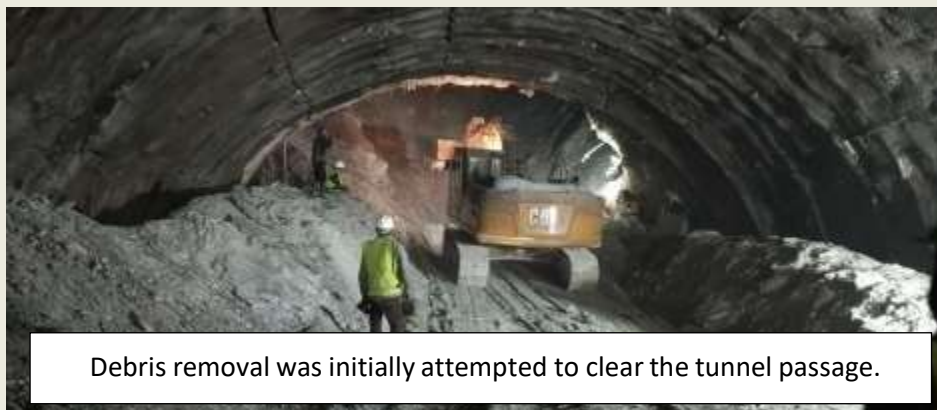
Debris removal was initially attempted to clear the tunnel passage.

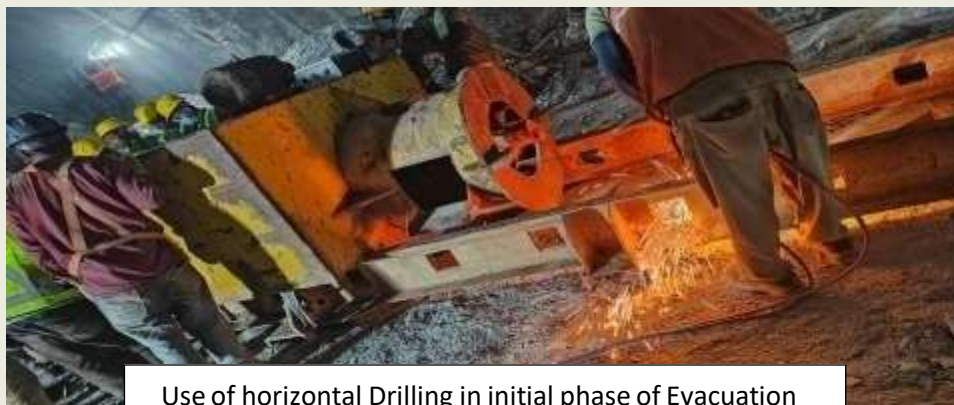
Use of horizontal Drilling in initial phase of Evacuation

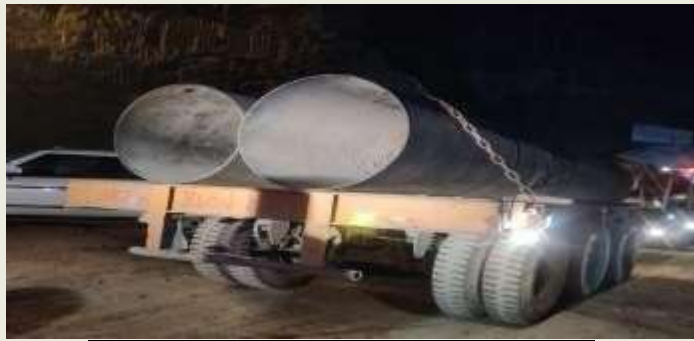
Mild Steel MS Pipe for Evacuation

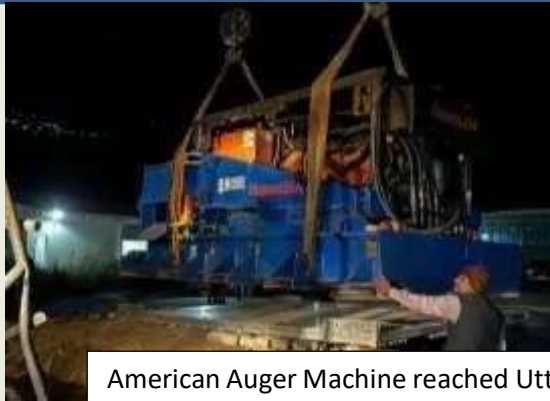
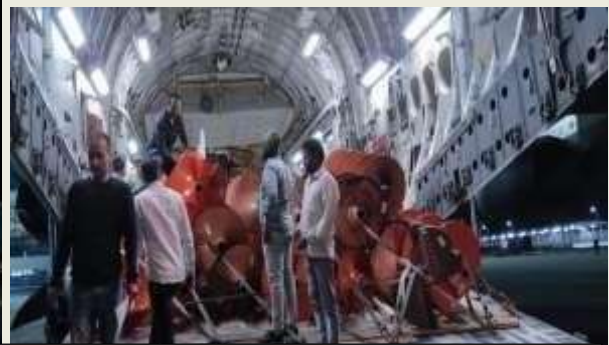
American Auger Machine reached Uttarkashi to speed up the drilling

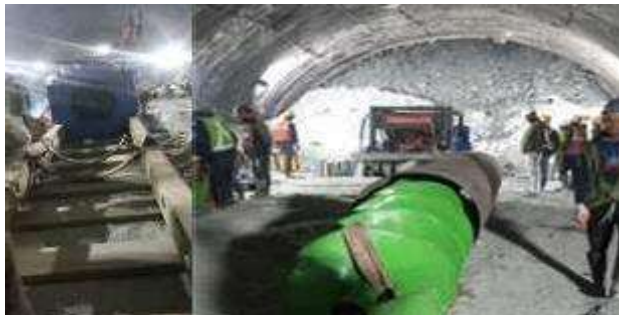
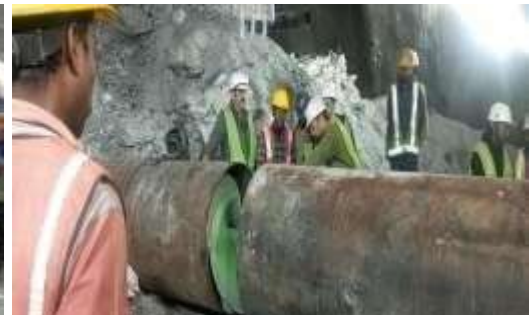
Connecting of Steel MS Pipe for inserting to initiate the safe evacuation.

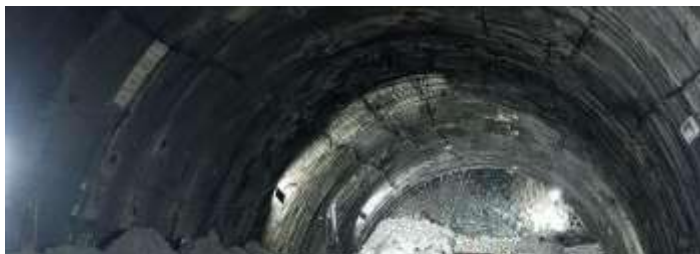
Iron Rib Protection work near the collapsed area for safety

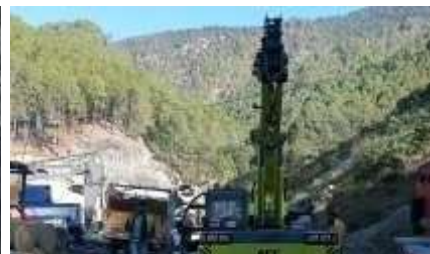
Hydra Crane for removal of Debris

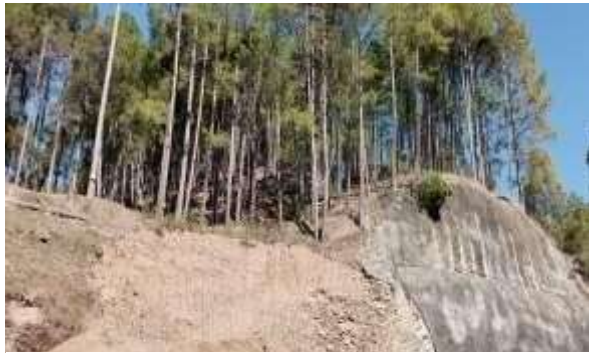
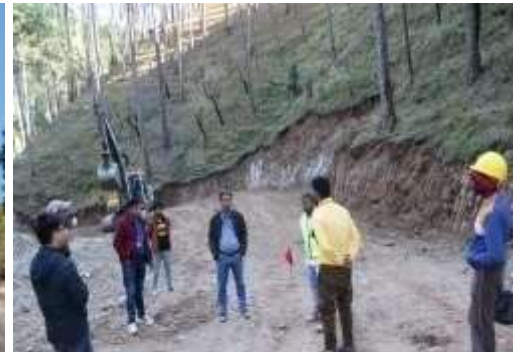
Construction of Approach road by BRO and selection of point for vertical drilling

infrastructure required for vertical drilling. The access road has been successfully completed, and an electric connection has been provided to RVNL, ensuring uninterrupted power supply for the drilling operations. Furthermore, the construction of the platform for vertical drilling has been finalized, providing a stable foundation for the drilling activities.

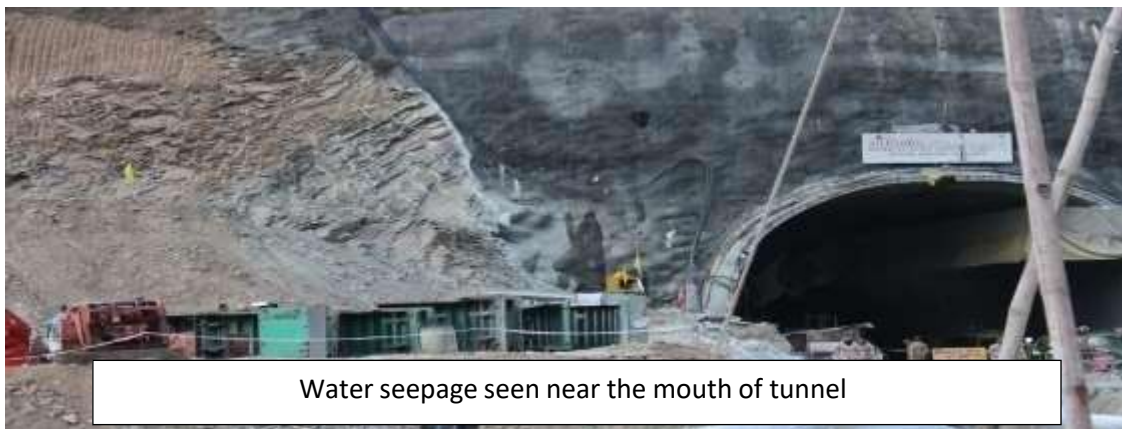
Water seepage seen near the mouth of tunnel

**B. Water Seepage and Erosion:** If there was indeed a hidden loose patch of rock, water seepage could have played a crucial role in the collapse. Water infiltration into the rock mass can weaken it over time, especially if the rock is susceptible to dissolution or erosion as both the rock type present near the construction site are weak metamorphic rocks i.e. chloritic phyllite and meta silt stone. The compromised rock might have allowed water to seep through, creating an unseen void above the tunnel structure. Over time, this void could have expanded, weakening the structural integrity of the rock mass and the tunnel.

**4.9 De-watering:** Given the critical necessity of de-watering the tunnel due to machinery being trapped behind a collapsed section, it is strongly recommended to prioritize the resolution of this issue once construction work resumes. The project site manager's insights indicate that water ingress is causing damage to construction- related machinery, underscoring the urgency of addressing this concern. A systematic approach, including initial assessments to identify the water source and strategic implementation of de-watering methods such as sump pumps, well point systems, and submersible pumps, is crucial. Establishing drainage systems within the tunnel and continuous monitoring will facilitate the safe removal of water, allowing for the efficient recommencement of construction activities. Implementing preventative measures, such as improving tunnel lining and waterproofing, is essential to control water ingress in the future.

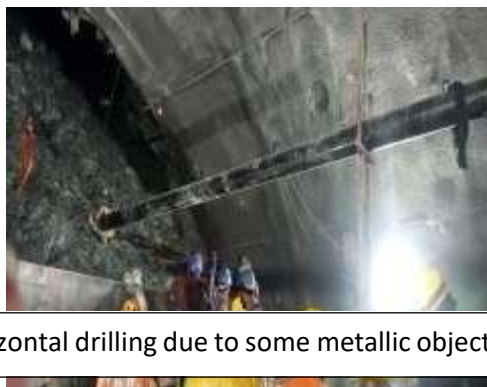
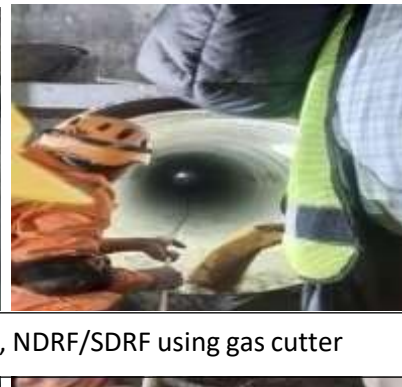
Hindrance in horizontal drilling due to some metallic object, NDRF/SDRF using gas cutter

During the cutting procedure, it was observed that manual cutting using gas cutters was the most efficient method. Therefore, the gas-cutting process was resumed on November 27, 2023, leading to the successful removal of the entire length of the auger. Subsequent visual inspection revealed that the auger cutter had become entangled with lattice girder bars, causing damage to a 1.5-meter section of the 800-meter passage pipe. Gas cutting was employed to remove the remaining pipe length, along with the obstruction caused by lattice girder and reinforcement. The entire process was completed by the evening of November 27, 2023. Additionally, the shotcrete lump in front of the pipe was manually broken into pieces using a rock breaker.

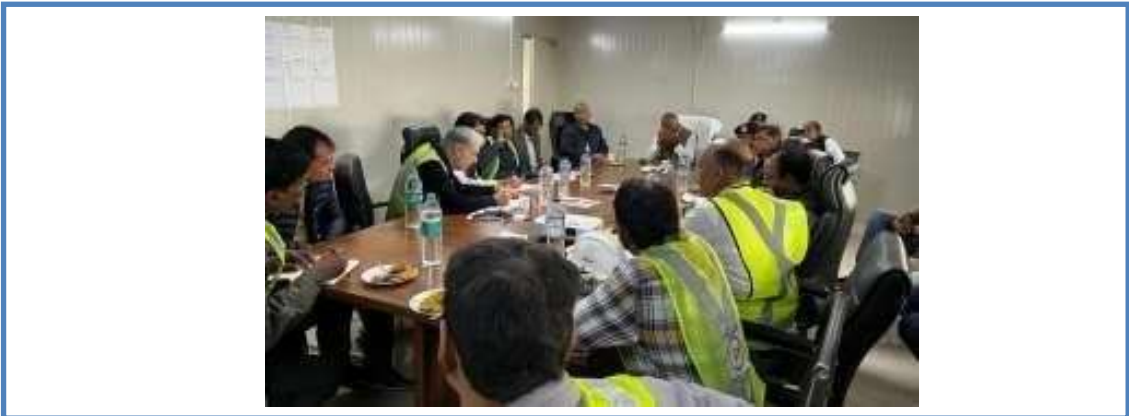
Due to metallic hindrance auger machine got stuck, strategies to speed up the evacuation

On November 24, 2023, the auger had to be fully retracted to assess any additional damage to the pipe. After removing the auger, a Ground Penetration Radar (GPR) test was conducted to identify any other metallic obstructions in the pipeline. The welder's team re-entered the pipe to cut the damaged and bent section. Once the cutting was completed, the auger was reassembled, and all augers were reinserted. The insertion of the 10th pipe, measuring 4.7 meters in length, began in the afternoon of November 24, 2023. By evening, a length of 2.2 meters had been inserted, resulting in a total length of 46.9 meters. However, the pushing of pipes was once again halted due to an obstruction.

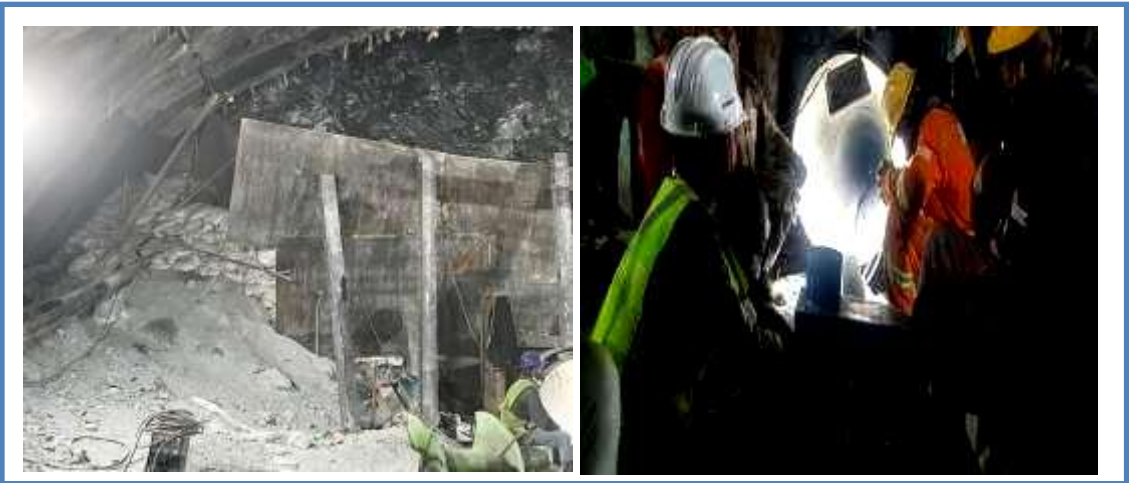
Fortification of the mouth of collapsed section for safety and gas cutter to remove auger machine

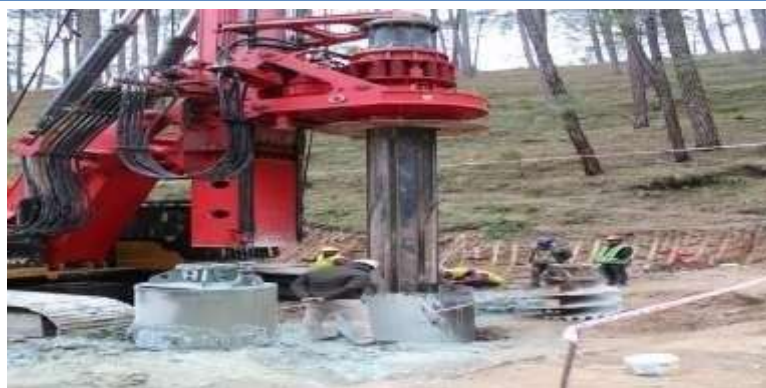
Vertical Drilling on the roof of tunnel for alternative rescue of workers
