Case studies: Baliyanala and Kedarnath

H. C. Singh

Executive Engineer,

Irrigation Division Nainital

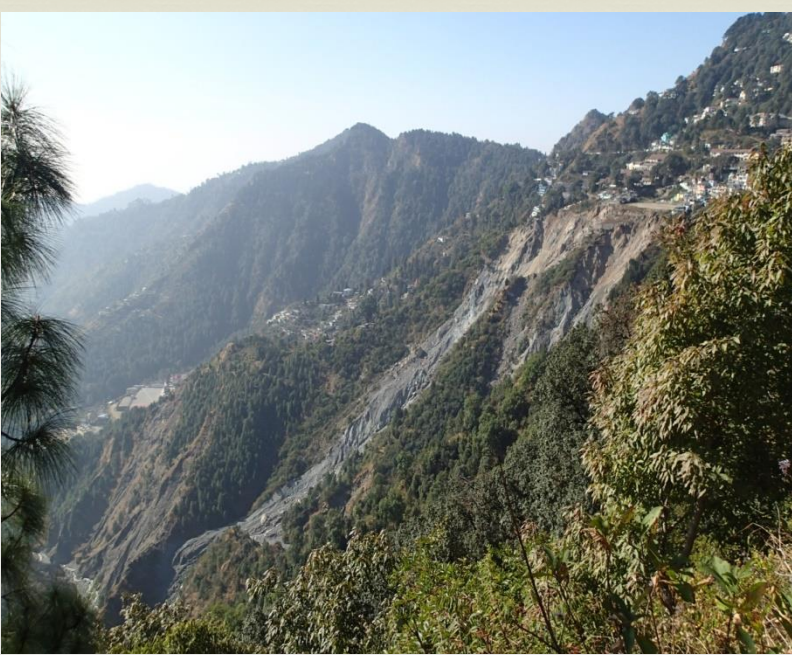
View of target slope
