Case studies: Baliyanala and Kedarnath

H. C. Singh

Executive Engineer,

Irrigation Division Nainital

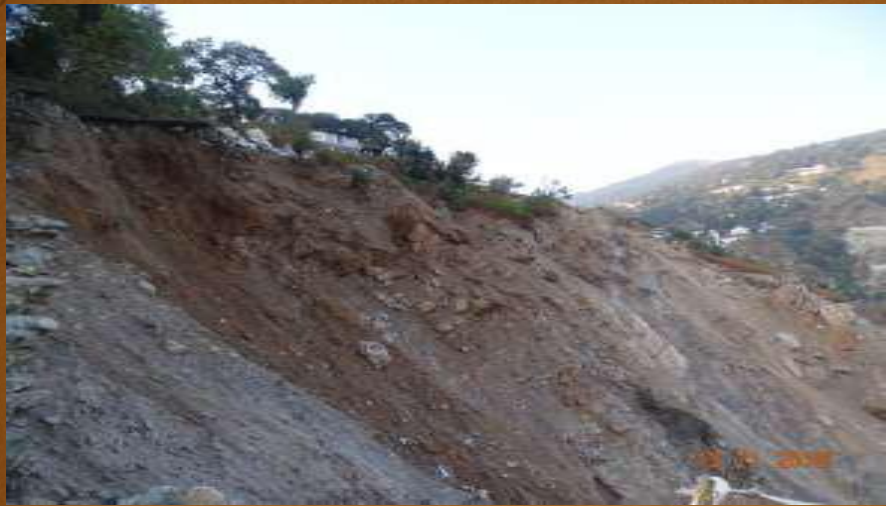
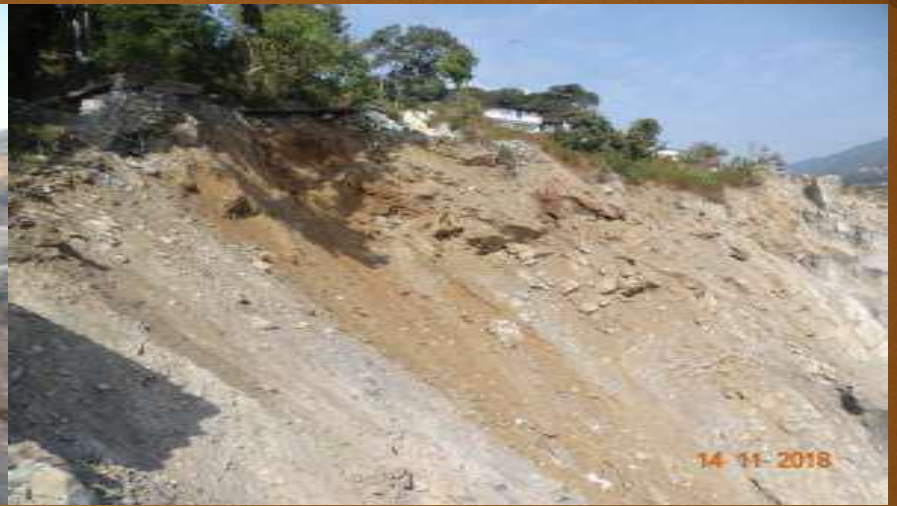
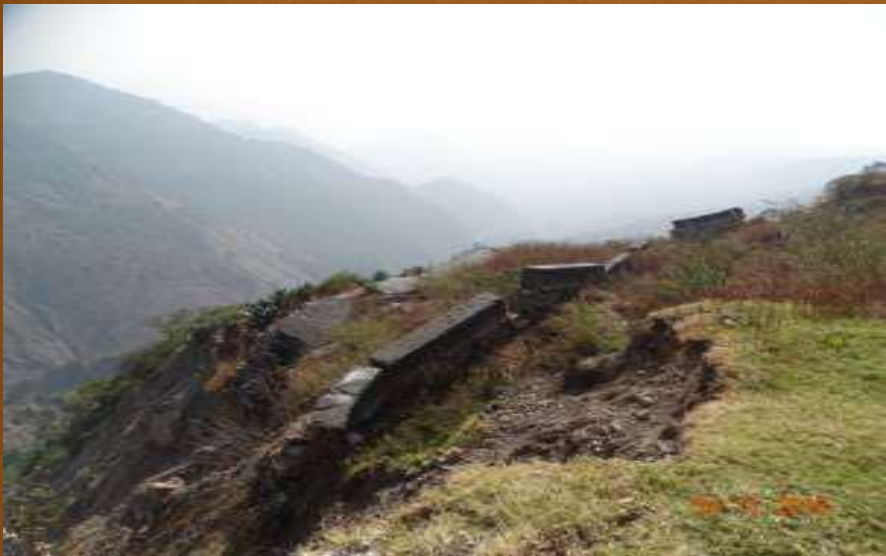
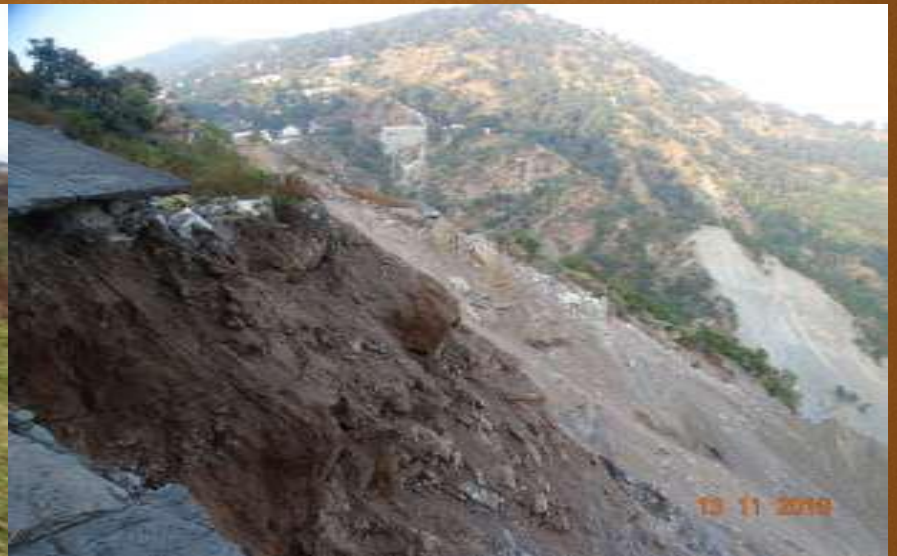
**Close up view of the main scarp of the
Baliyanala landslide**

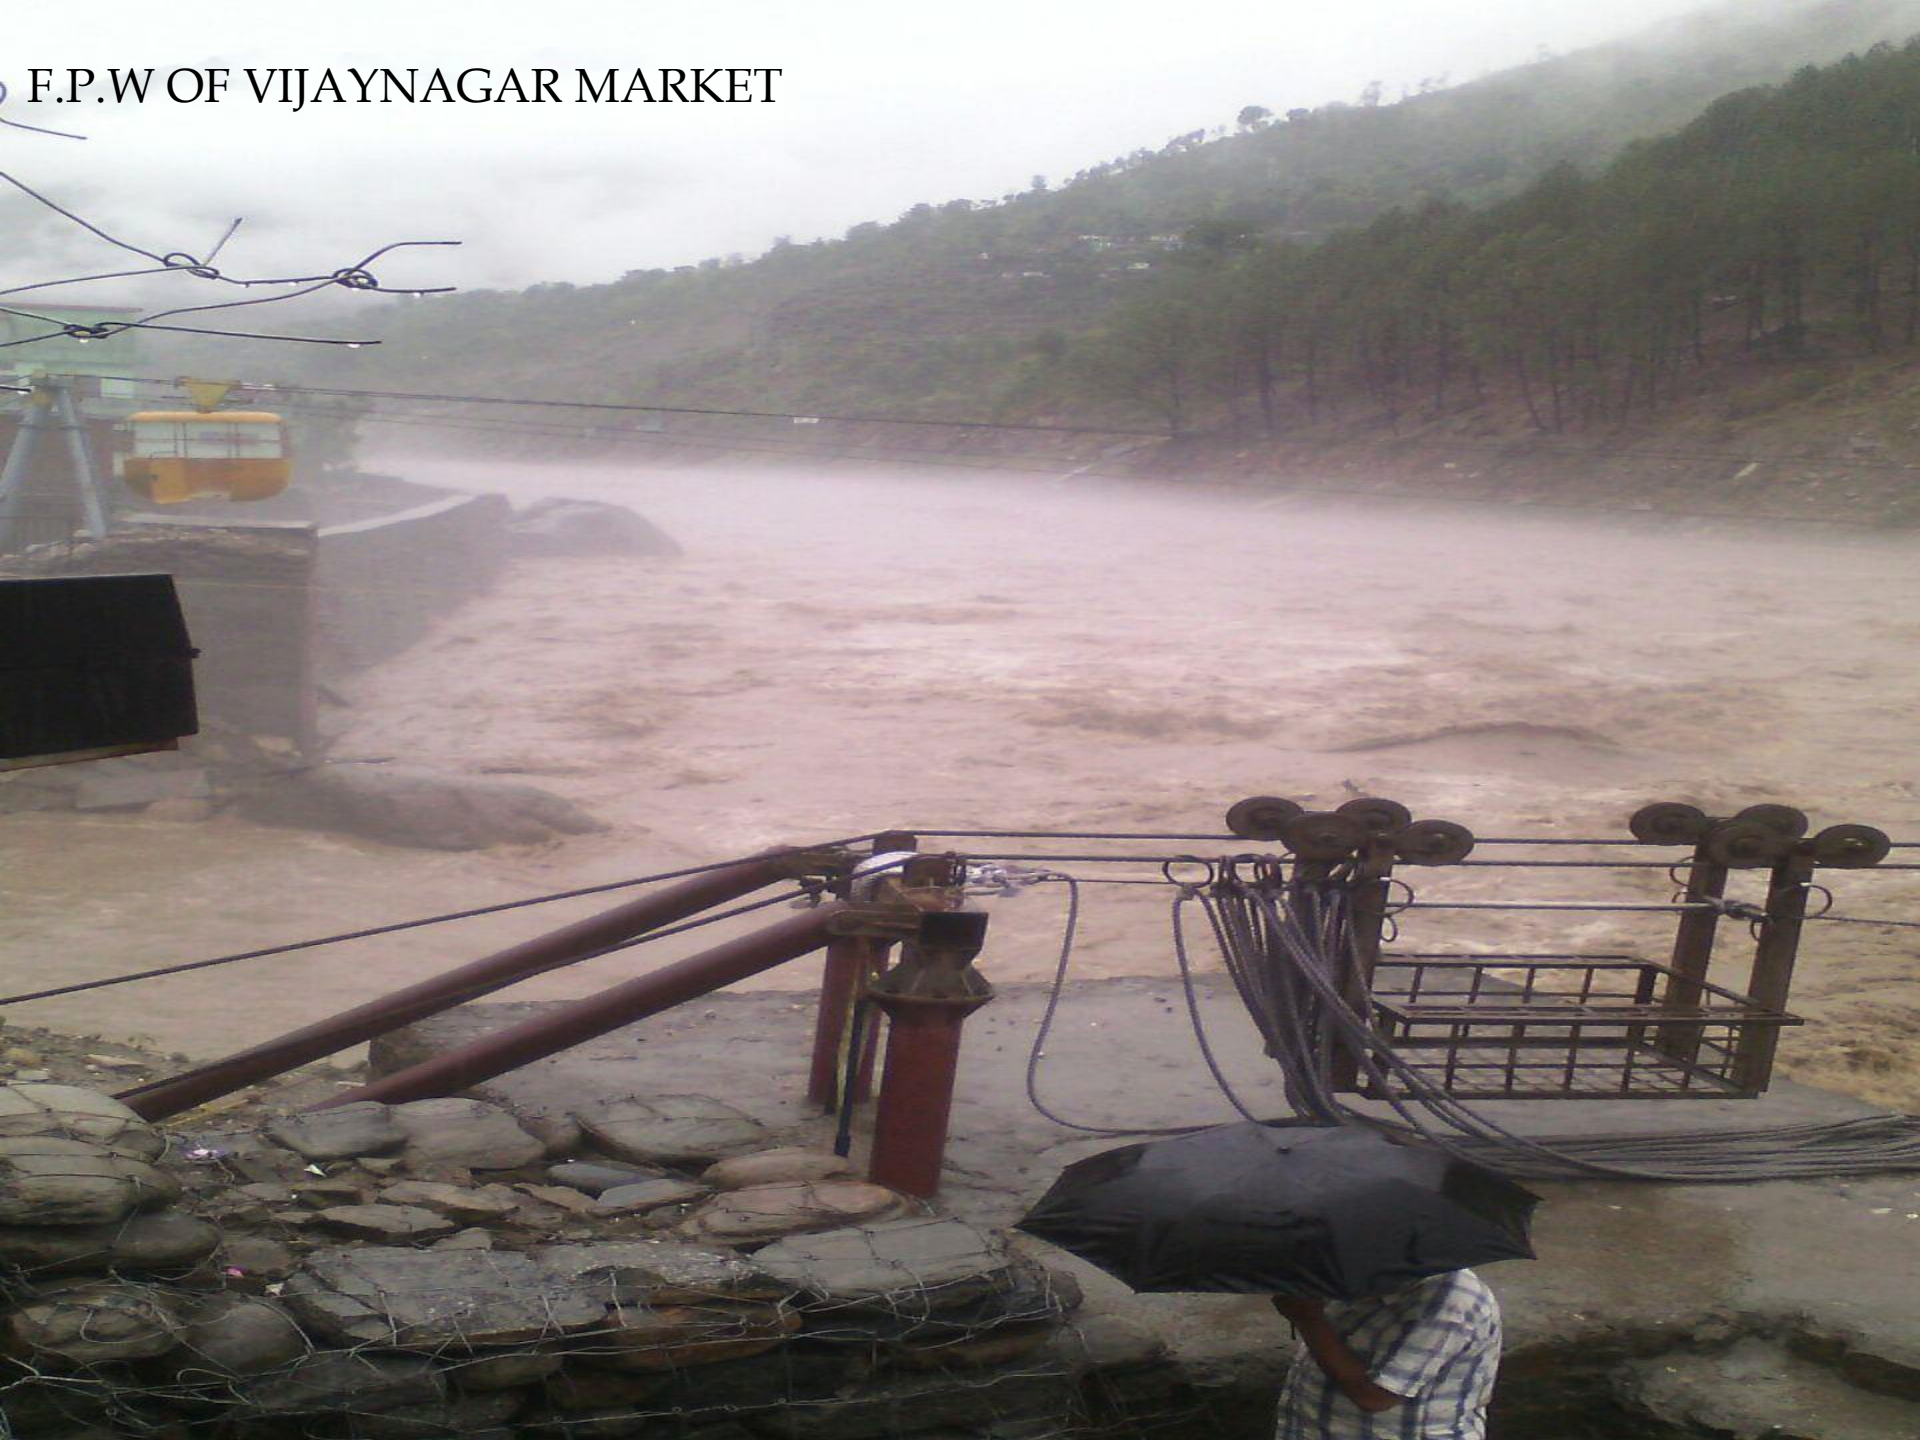
F.P.W OF VIJAYNAGAR MARKET
